Report No. CG-D-02-98

IMPROVED INSPECTION OF WOODEN VESSEL FASTENERS

U.S. Coast Guard
Research and Development Center
1082 Shennecossett Road
Groton, CT 06340-6096

Final Report
August 1997

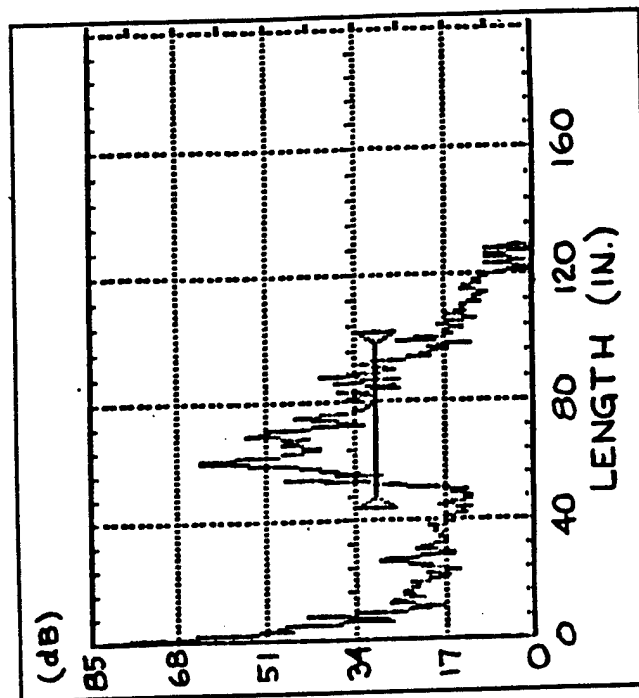
FIGURE 4. Ultrasonic Output Showing a Good Fastener

A-scan of 32-inch long copper alloy drift pin in the starboard sister keelson (sail locker area). The pin is in good condition with light wastage on the inboard 8-10 inches.

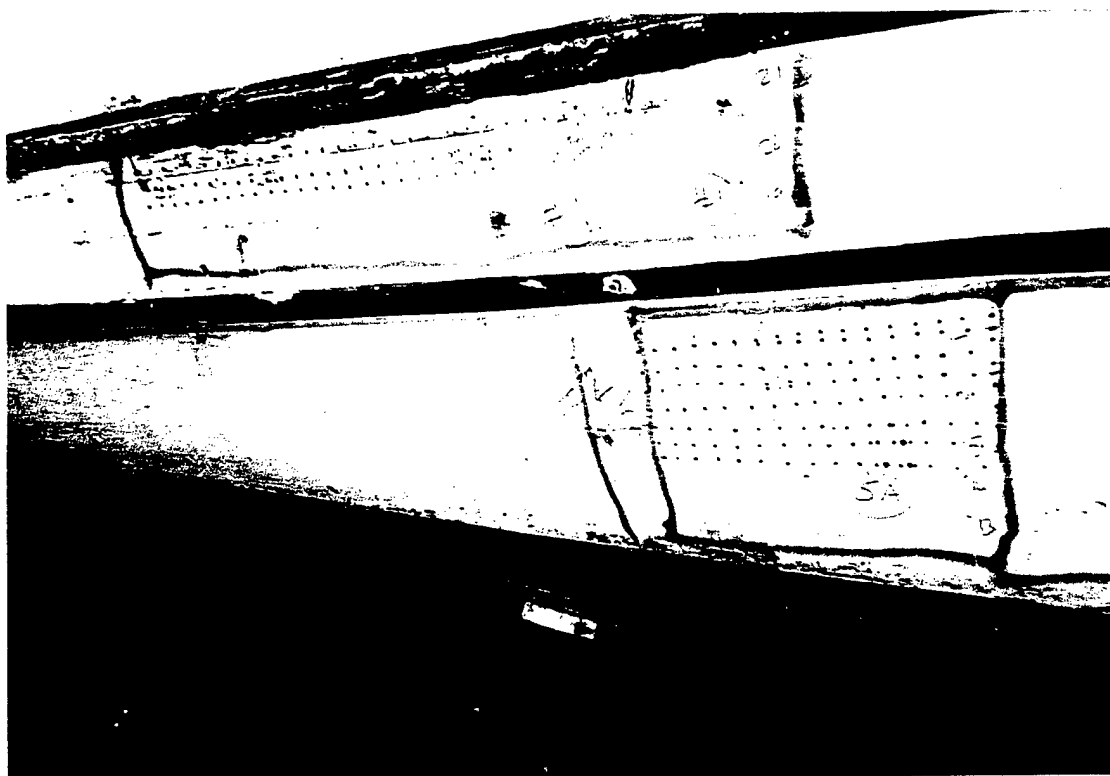
FIGURE 14. Test Area Locations

<u>Area</u>	<u>Description</u>
1.	A five foot long area just below the rub rail. The condition of the area ranges from good to a hole which has been created due to rot. (Figure 15)

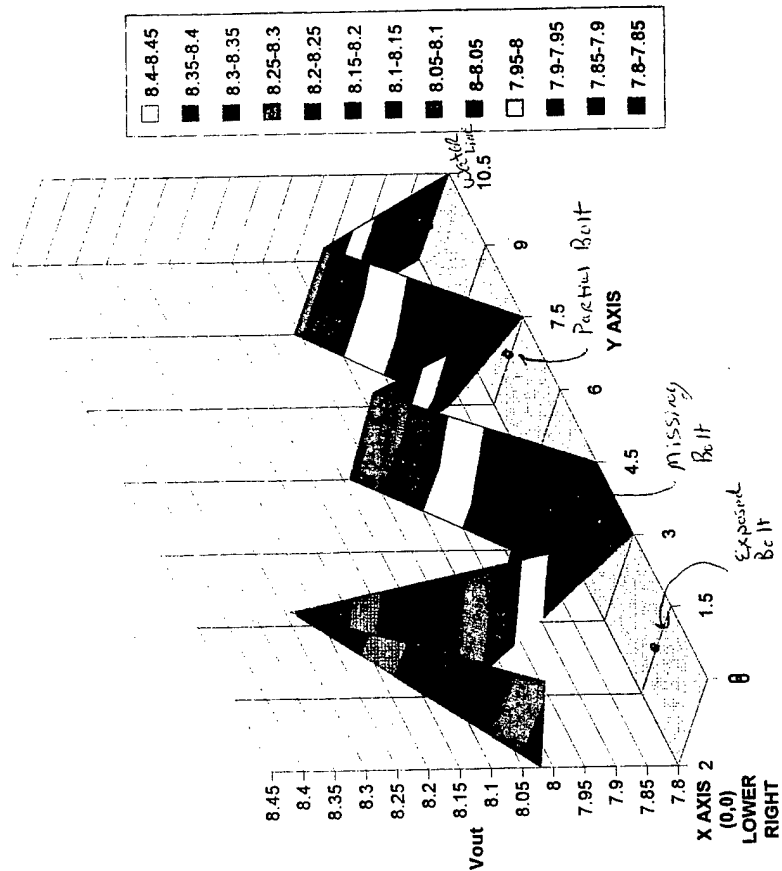
FIGURE 29. Capaciflector Results (Area 4)

In Area 4, under the waterline, the readings were taken at a frame (see Figure 29). There was wood missing from around two of the bolts. In addition, the bolt was exposed at one location at ($y = 1.5$), missing from a second (at $y = 4.5$), and only a partial bolt was located at a third location (at $y = 7.5$). The readings are consistent here as a partial bolt and an empty bolt hole gave lower readings than the intact bolt.

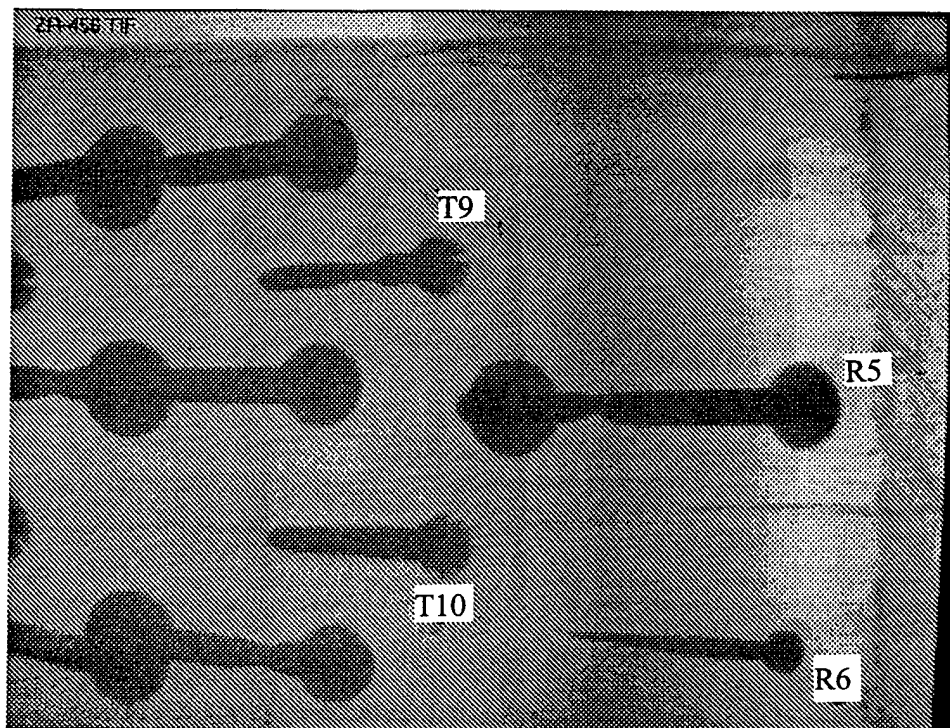
FIGURE 37. Real time X-ray of Test Fixture

In the real time shot (see Figure 37), a more limited area is covered. The results are a positive picture so that this shot is a mirror image of the conventional x-ray. Only fixture fasteners R5 and R4, and Butt 1 fasteners 6 through 10 are covered. The defects are easily seen.
